INSTALLATION RESTORATION PROGRAM PHASE 2
CONFIRMATION/QUANTIFICATION STAGE 1 BERGSTROM AFB TEXAS
VOLUME 1(U) RADIAN CORP AUSTIN TX 27 APR 87

BERGSTROM AIR FORCE BASE, TEXAS 78743

April 1987

Final Report, March 1984 - August 1986

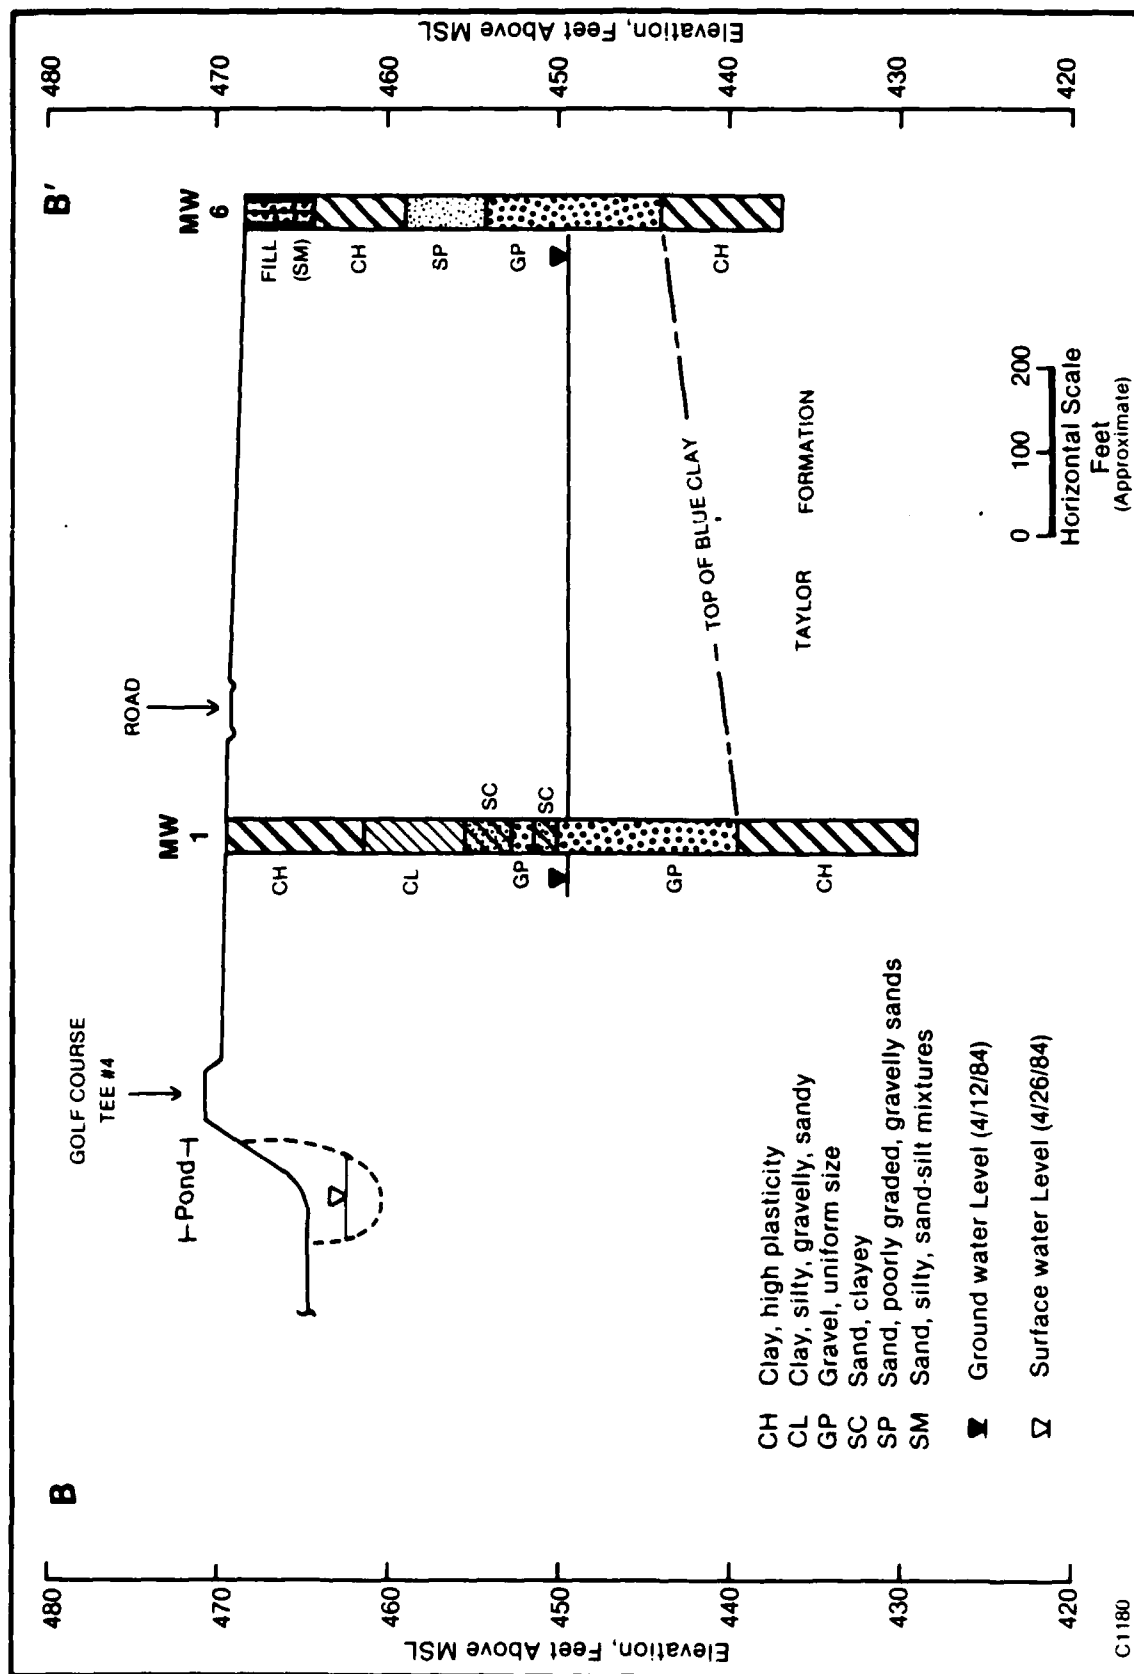
Figure 4-3. Cross-Section B-B' - Sites 3, 4, 5, 6, 7, and 14, Combined Southeast Landfill

Six monitoring wells were installed in the Combined Southeast Landfill area. In addition, two borings drilled did not encounter groundwater and were not completed as monitoring wells. The locations of the monitoring wells (MW), borings, and geologic cross sections (Figure 4-2 and 4-3) are shown in Figure 4-1.
